## Landfill Gas Risk Assessment – 39-45 and 40-46 Cyril Beechey Lane, Cranbourne

*Maclaw No.10 Pty Ltd & Greenridge Properties Pty Ltd*

**27 July 2021**

# Gas Vapour Management Plan, 39-45 Cyril Beechey Lane, Cranbourne

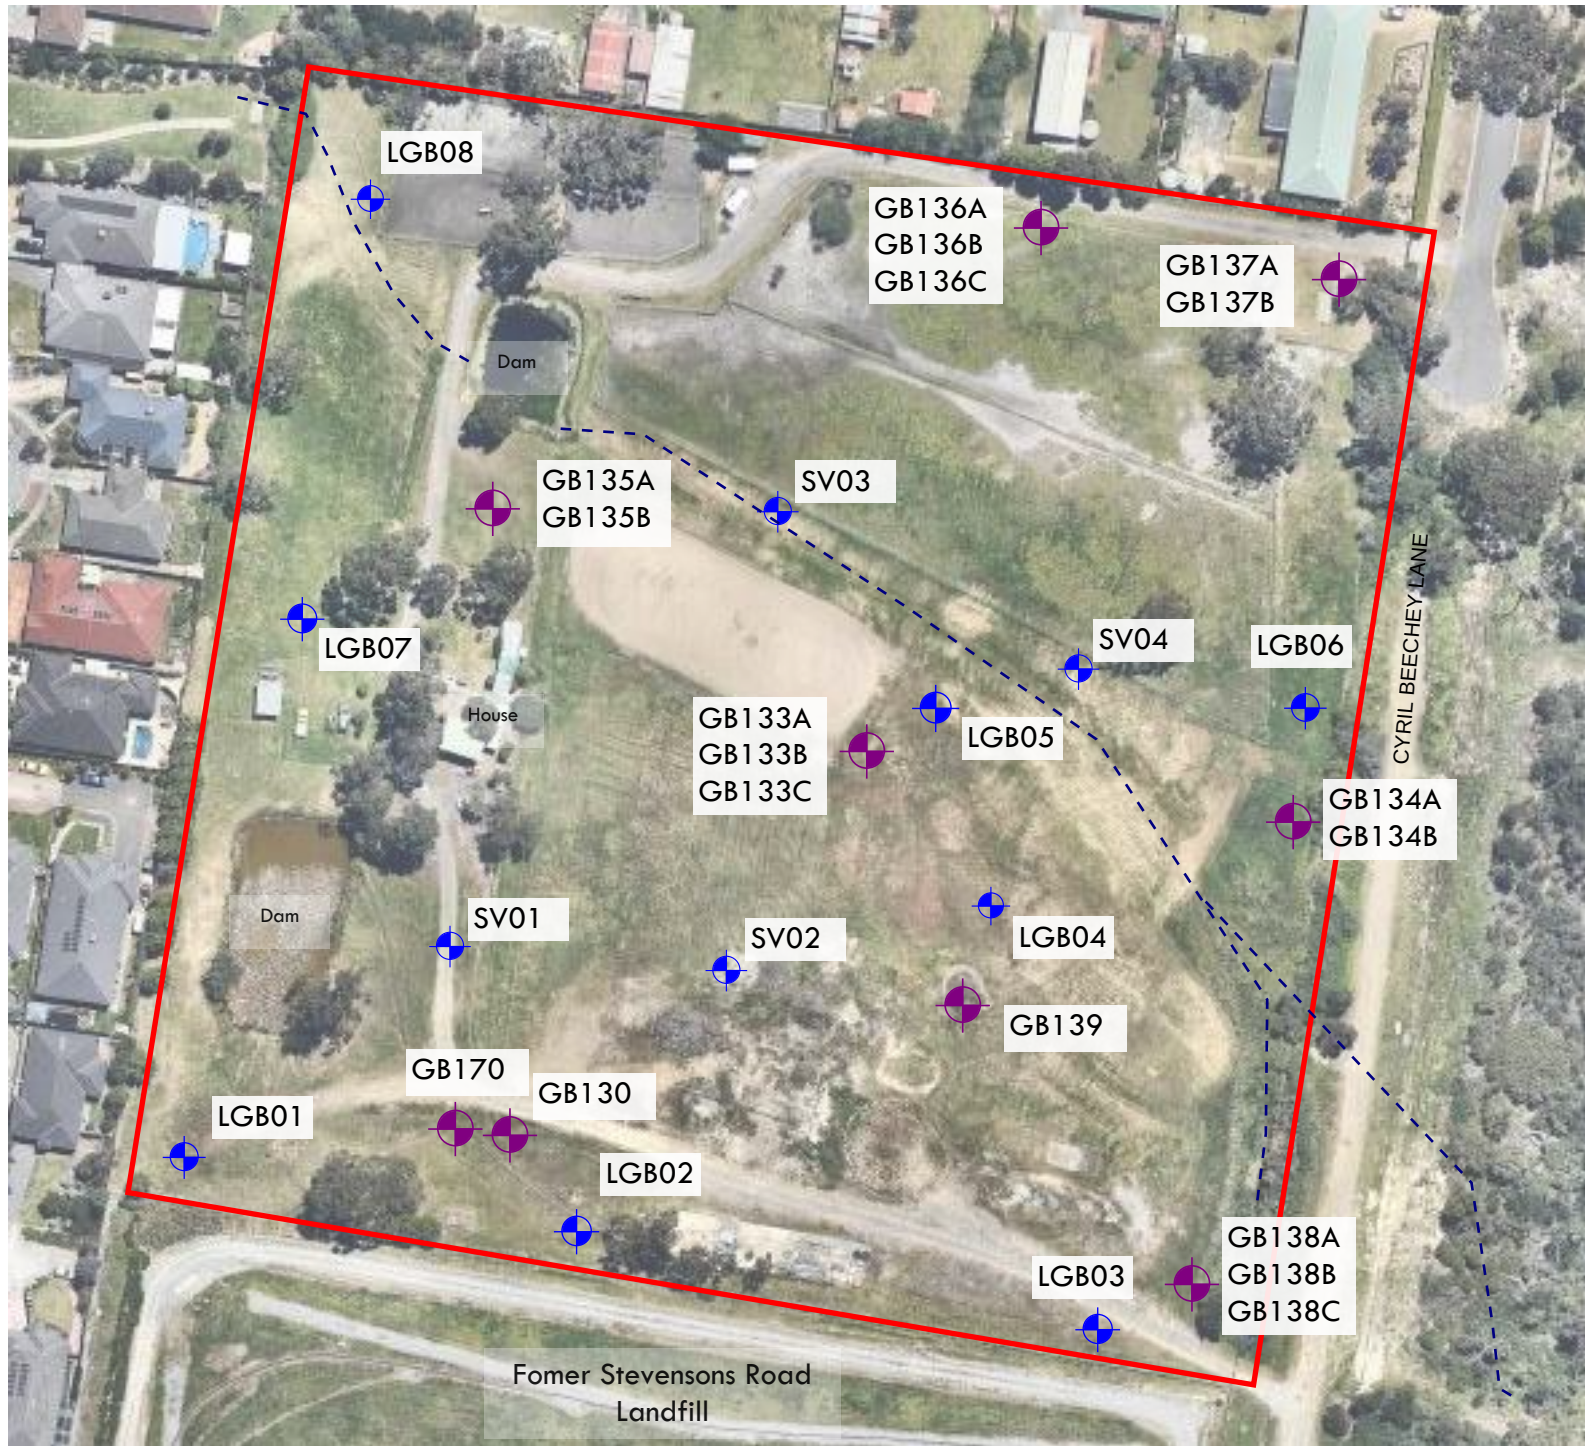
| FIGURE: | <b>3A</b> |

- Site Boundary
- Approximate DRC Landfill Gas Bore Locations
- Approximate Location CCC Landfill Gas Bores
- Current and Former Drainage Lines

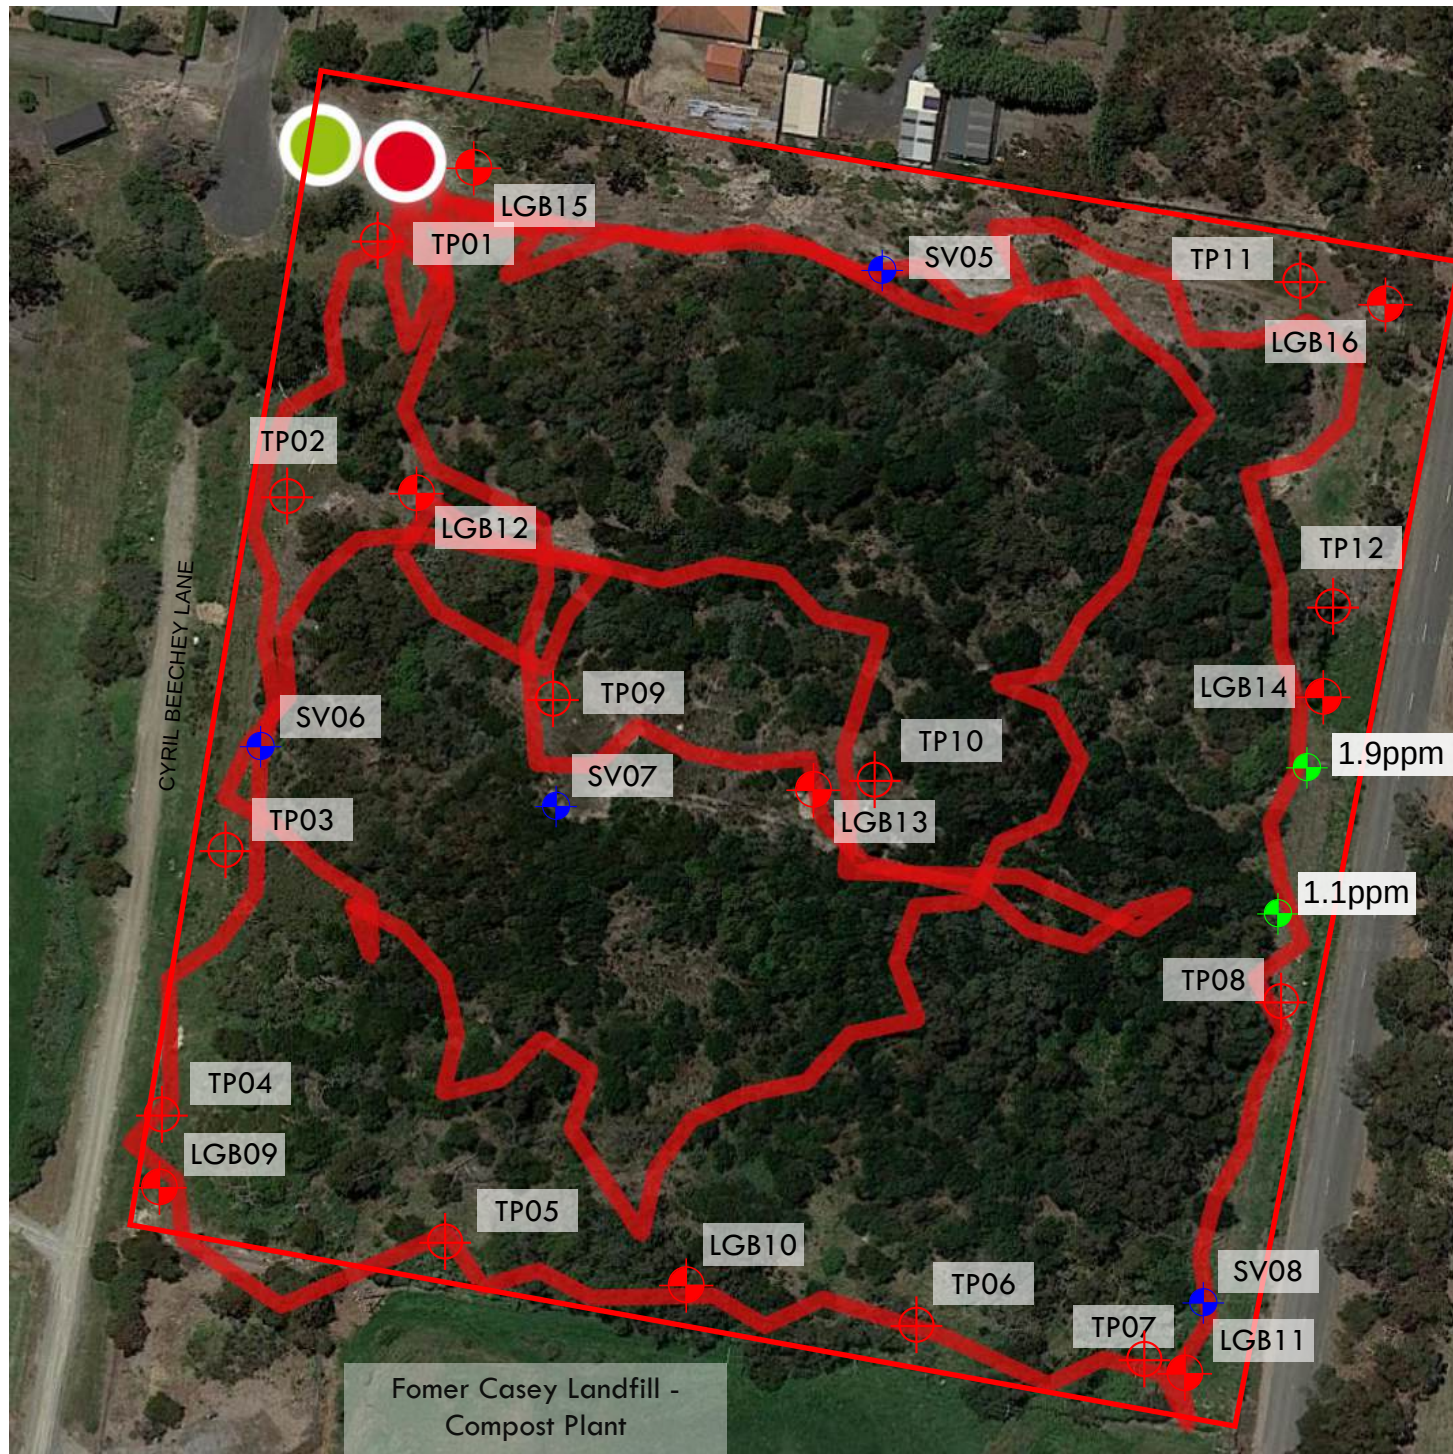
**4B**

- Site Boundary
- Approximate Landfill Gas Bore Locations
- Approximate Test Pit Locations
- Approximate Reading locations

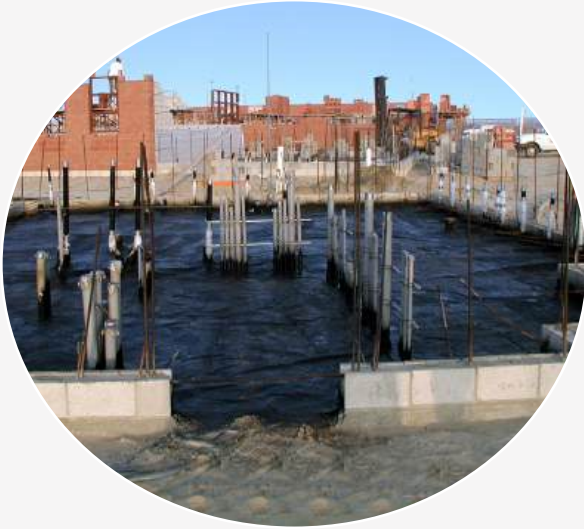
## High School | California | 300,000 sf

*Use:* School built on former dairy farm land

*Mitigation System :* PERLASTIC™ gas vapor membrane system and “passive” venting system

*Application:* PERLASTIC™ gas vapor membrane was spray-applied onto a geotextile fabric under the slab to provide an impermeable gas vapor barrier that prevents gas intrusion.

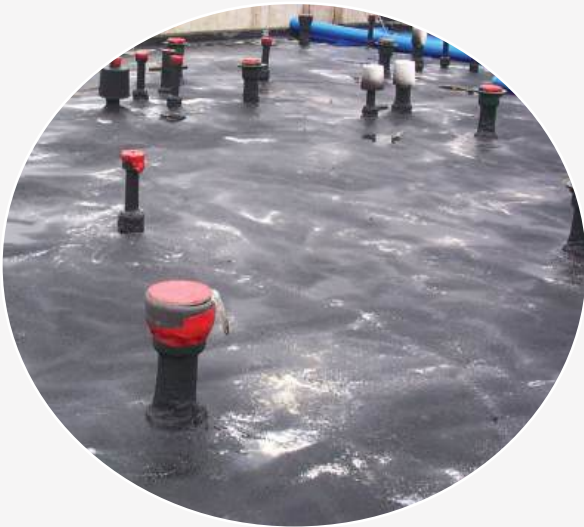
## Restaurant | Illinois | 2,400 sf

*Use:* Fast food restaurant on former service station site

*Mitigation System:* PERLASTIC™ gas vapor membrane system

*Application:* PERLASTIC™ gas vapor membrane system spray-applied under the slab and sealed to all footings and pipe penetrations.

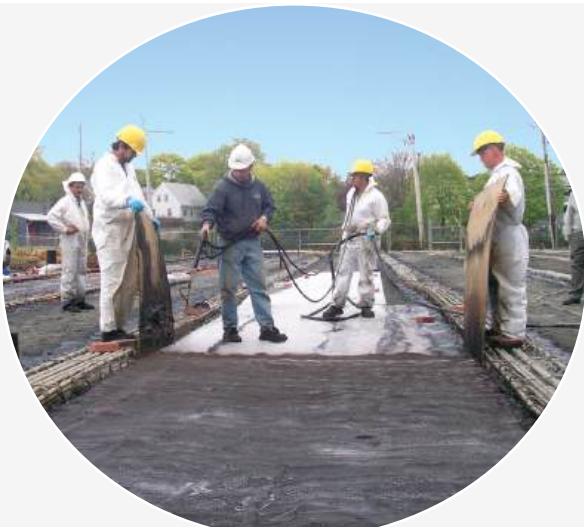
## Public Storage | Massachusetts | 32,000 sf

*Use:* Former tannery site

*Mitigation System:* Remediation of soil, PERLASTIC™ gas vapor membrane, and an “active” venting system

*Application:* PERLASTIC™ was spray-applied under slab and onto geotextile fabric, attached onto piles, pile caps, grade beams and penetrations.

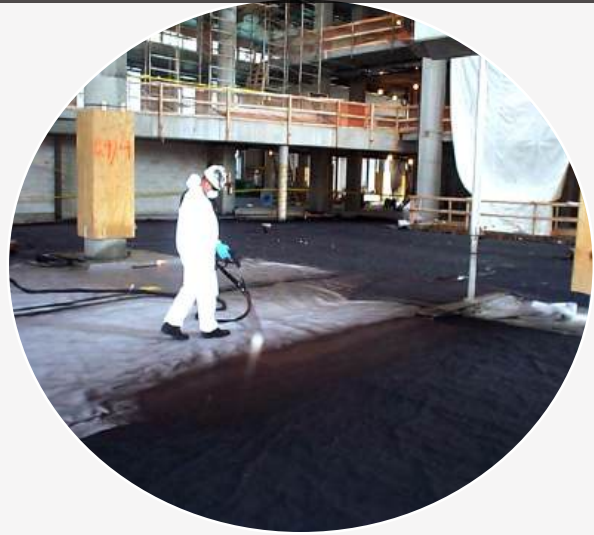
### Big Box Center | Oregon | 150,000 sf

*Use:* Large retail store on closed landfill site

*Mitigation System:* PERLASTIC™ gas vapor membrane and a geotextile composite venting system

*Application:* Vent pipes were used to direct methane gas to roof for release; PERLASTIC™ membrane applied to provide barrier between the soil and structure to prevent intrusion of methane gas.

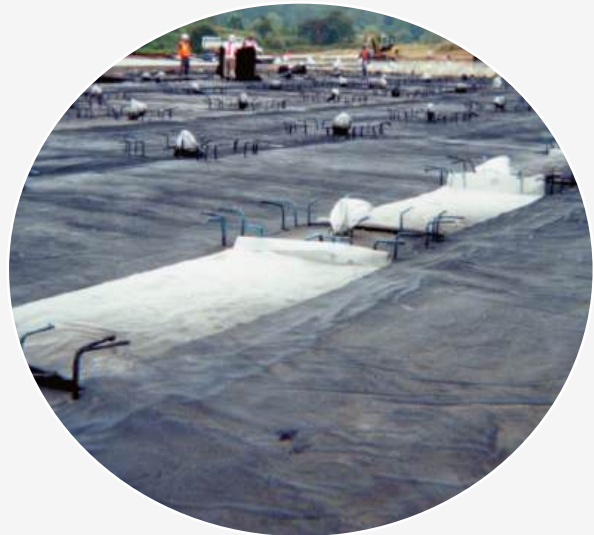
### Library | California | 400,000 sf

*Use:* New public library situated 50 feet below grade

*Mitigation System:* PERLASTIC™ gas vapor membrane and waterproofing system

*Application:* PERLASTIC™ spray-applied under the slab and up the walls to seal the entire building to prevent methane gas and water from migrating into the structure.

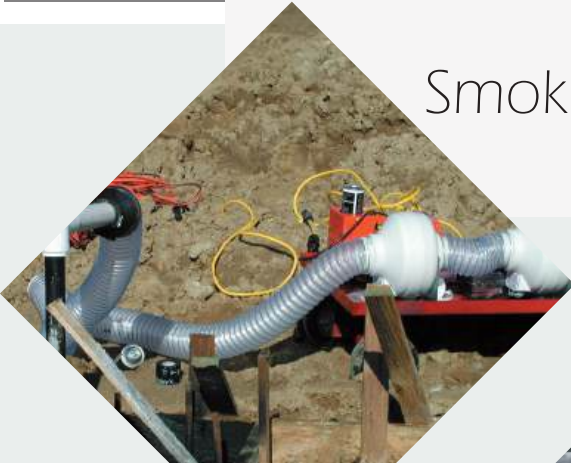
Equipment set-up  
for smoke test

A smoke test is a method of ensuring that a membrane is impermeable and free of holes. Smoke is pumped under the membrane for a specified period of time while the surface of the membrane is observed for minute holes where the smoke is clearly visible. Since the applicator is present during the smoke test, any holes can be immediately detected and repaired. This process has been field tested under hundreds of buildings and found to be highly successful. The smoke testing process assures engineers, developers, and owners that they are getting a fully tested, gas-tight membrane installation.

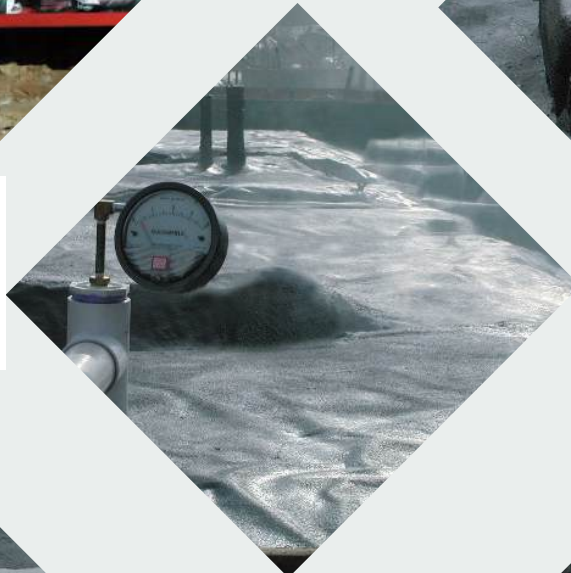
Starting smoke  
test procedure

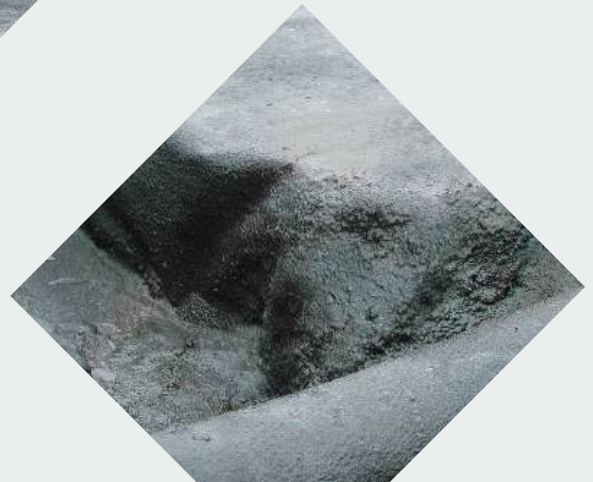
Patched  
membrane
